NATIONAL TRANSPORTATION SAFETY BOARD

MATERIALS LABORATORY FACTUAL REPORT

Report No 08-035

Place : Carmichael, Mississippi
Date : November 1, 2007
Vehicle : Dixie Pipeline Company
NTSB No. : DCA08MP001
Investigator : Rod Dyck

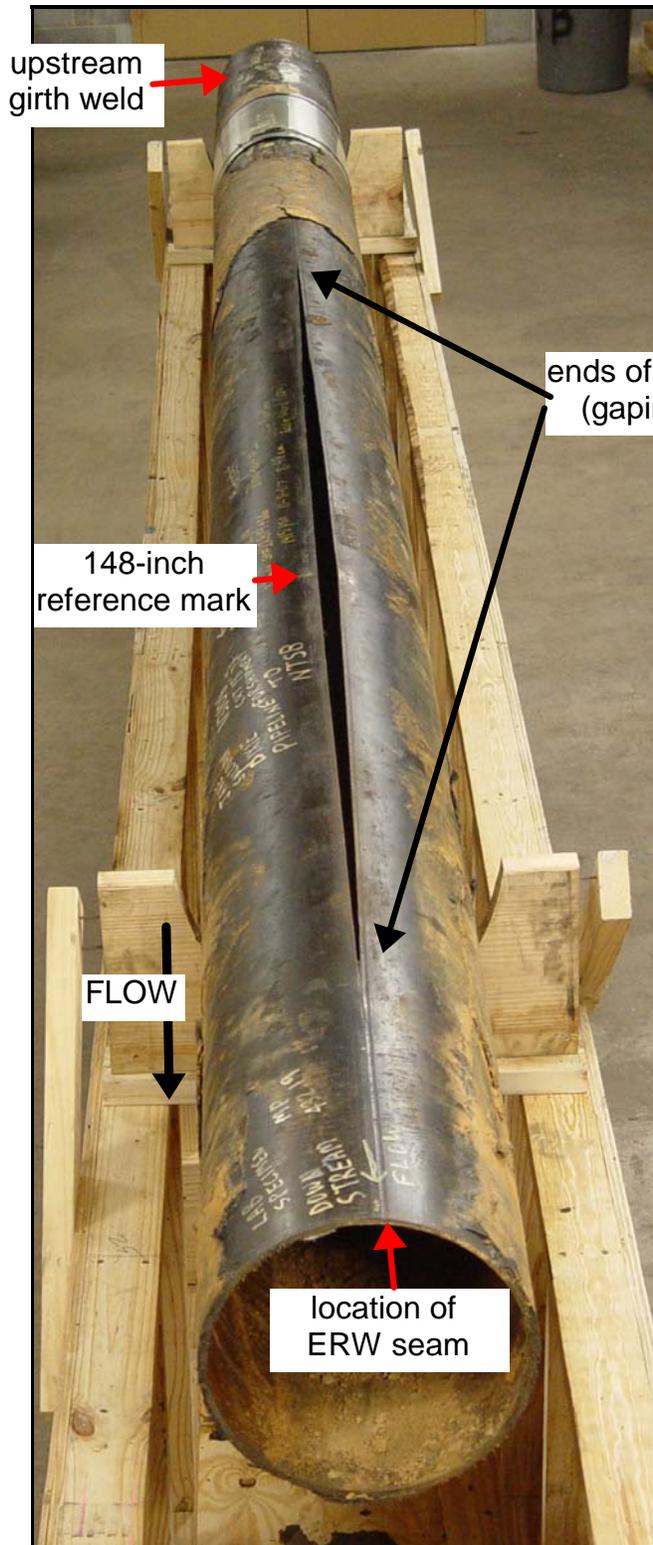
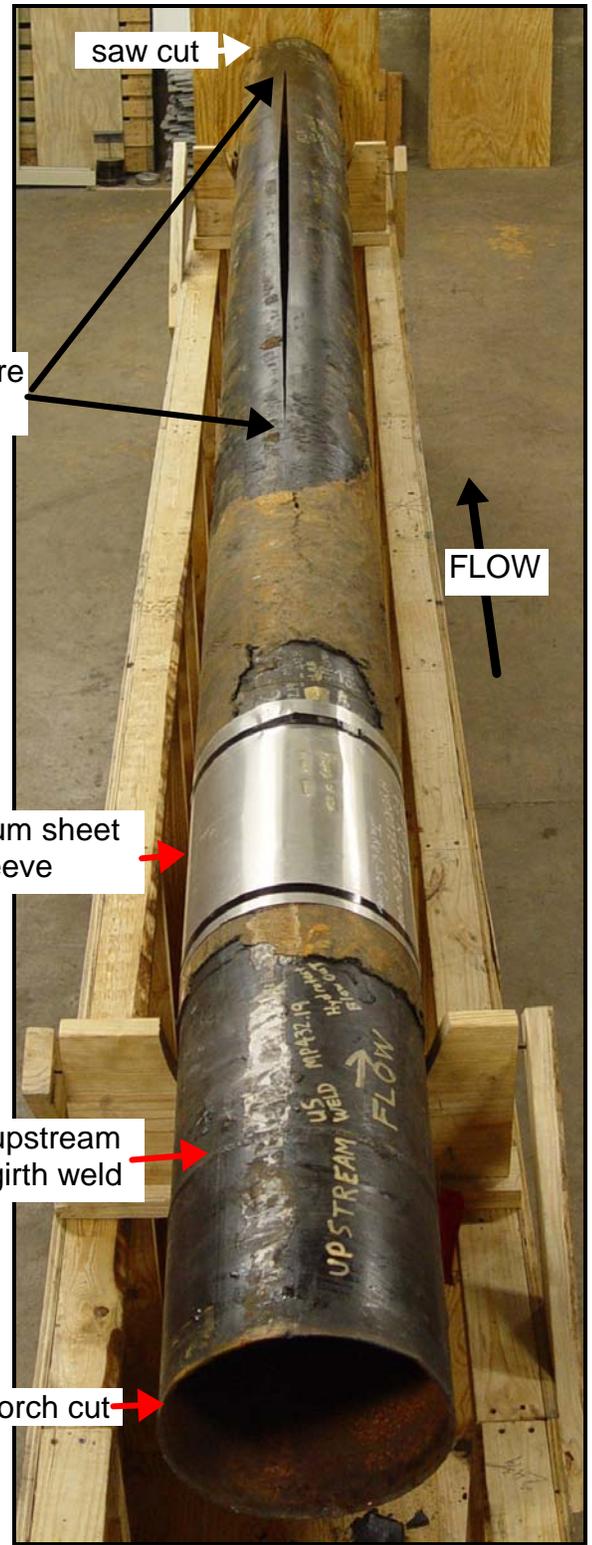
The pipe was subjected to a hydrostatic pressure test that resulted in a longitudinal rupture (gaping crack). Figure 1 show photographs of the as-received pipe segment. Upon receiving this pipe segment, the fracture faces were sprayed with WD-40 lubricant to preserve the fracture. The length of the as-received portion of the pipe measured approximately 219 inches (18 feet and 3 inches) and the length of the gaping crack measured approximately 126 inches (10 feet and 6 inches).

Figure 1. Photographs of the as-received pipe segment showing the downstream cut end (left side of page) and the upstream end (right side of page). An aluminum sheet sleeve with identification information was placed over the pipe in the area near the upstream girth weld prior to shipping.

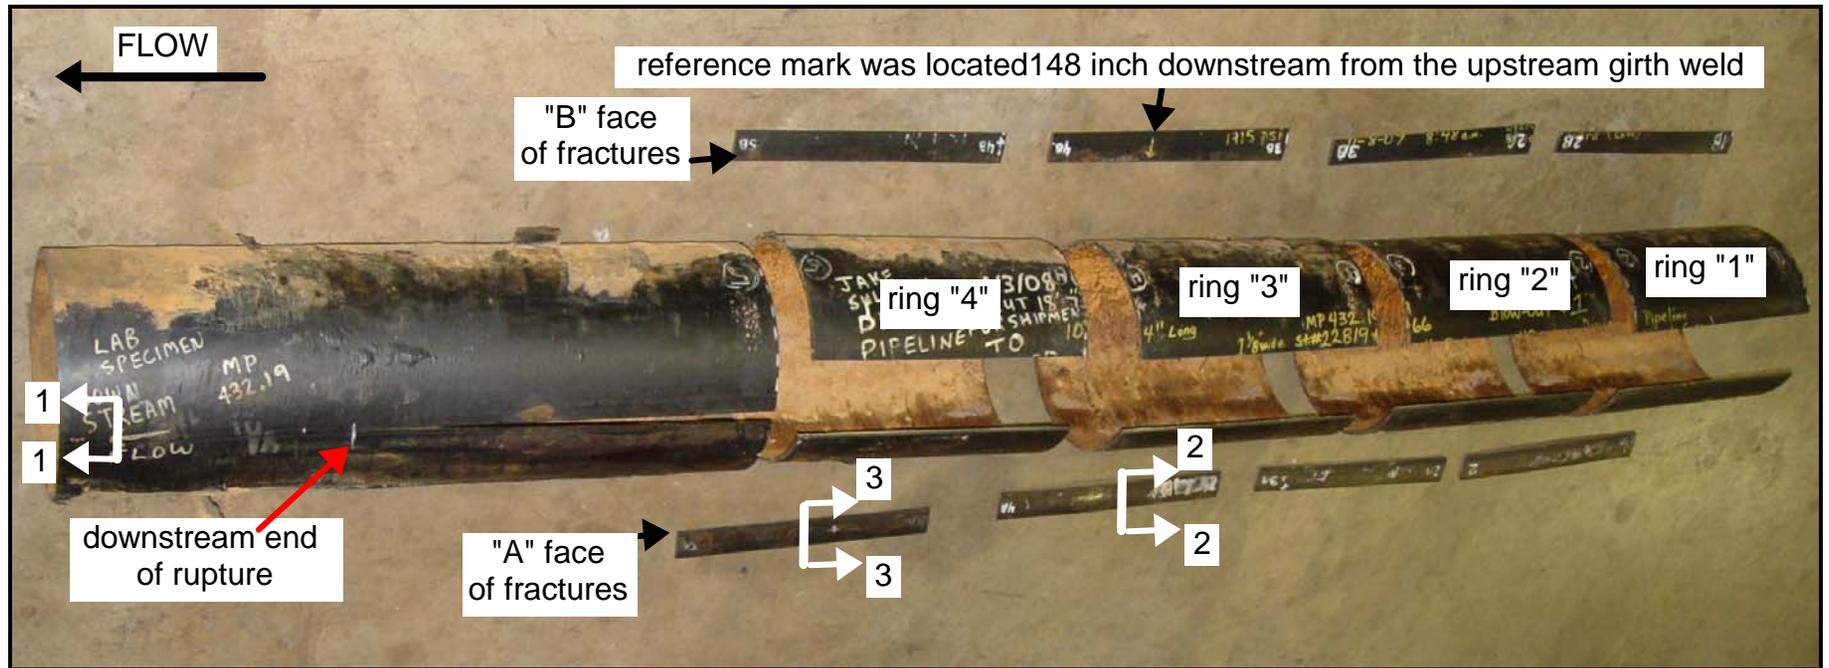
The wall of the pipe on the outside diameter at the downstream end contained a minor longitudinal weld depression consistent with a trim⁴ of an ERW seam at the 6 o'clock position looking downstream. The longitudinal rupture was within the area of the ERW seam. Metallographic cross sections (sections 1-1, 2-2, and 3-3) of the pipe later showed that the longitudinal mating fracture faces were through the material affected by the ERW process, and that the flat top portion of the ridge or flat bottom portion of the valley of an island feature actually were fractured along the curved portion of the upturned grains created when the edges were upset (deformed) during welding. Details of how the ERW seam fracture was found is discussed in the section titled "Metallurgical Sections of Intact and Fractured ERW Seams".

Figure 2. Photograph of the downstream end of the pipe after four ring pieces were cut from the downstream end of the gaping crack. Two inch wide strip portions that contained the fracture faces were cut from each ring piece and were placed next to their respective ring piece. The "B" face portion of the fracture faces are on the top side of the photograph and the mating fractures ("A" face) are shown on the bottom side of the photograph. The widest opening in the gaping crack was found approximately 148 inches downstream from the upstream girth weld. The upstream end of the gaping crack is not shown in this photograph.

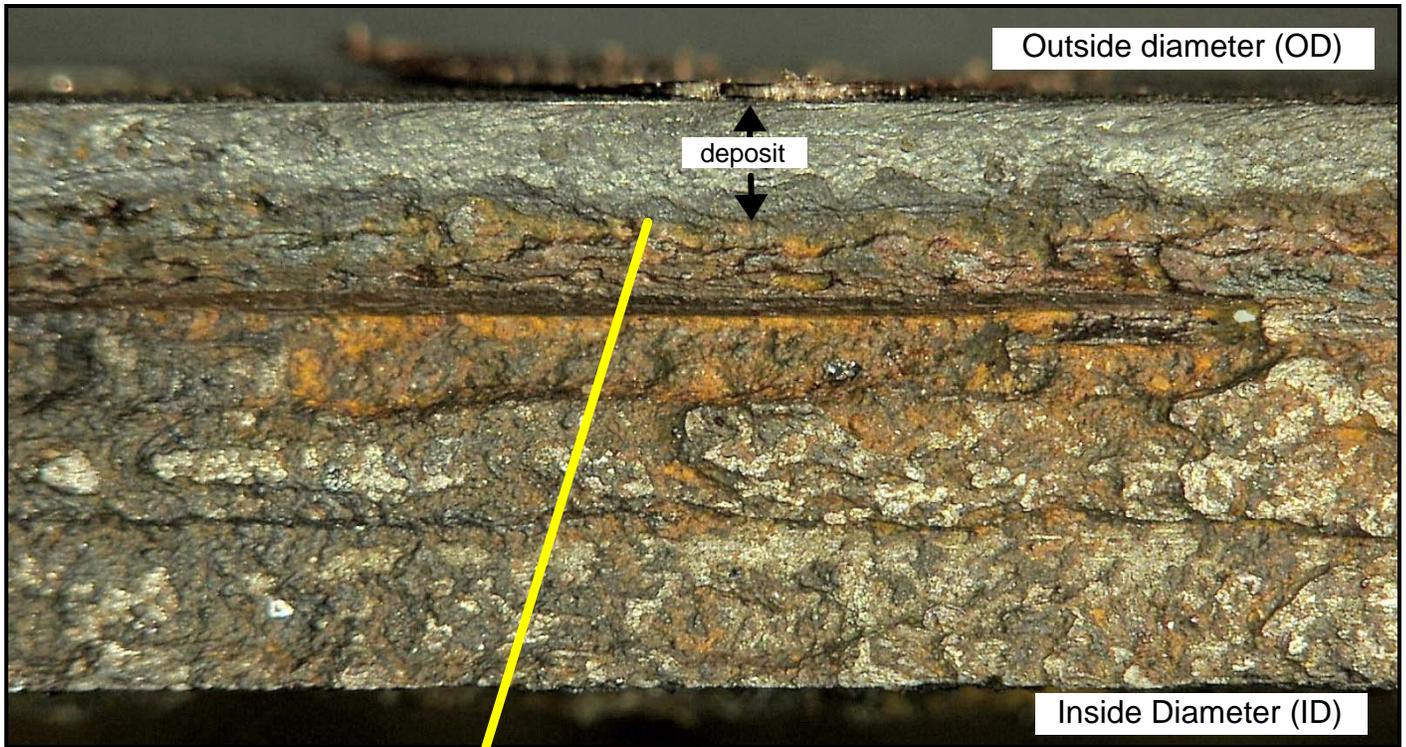
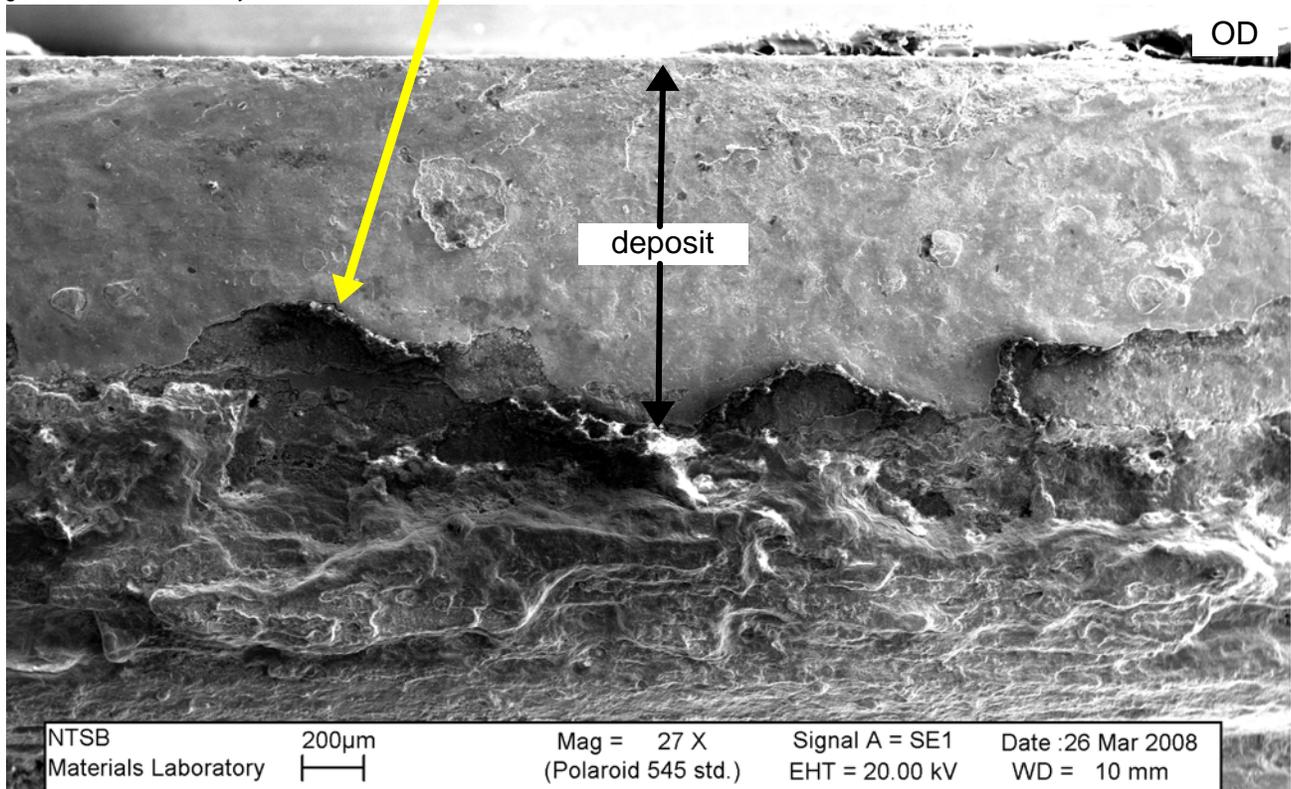
A 1-inch long piece of face "B" of the fracture that contained black-gray deposit "9" in table 1 was excised from the 2-inch wide strip portion of the pipe. Scanning electron microscope examination of the 1-inch long piece revealed the black-gray deposit was smooth compared to the surrounding fracture features; see the bottom photograph in figure 3. The deposit areas contained cracks in several areas, not visible in figure 3. The sample was rotated to view the fractured edges of the deposit. The thickness of the deposit measured approximately 10 micrometer (0.0004 inch). X-ray energy dispersive spectroscopy analysis of the smooth deposit produced a spectrum that contained major elemental peaks of iron and oxygen, consistent with iron oxide, and minor elemental peaks of carbon, manganese and silicon, see figure 5.

Figure 3. Photograph of a portion of the fracture from ring piece "4" showing the "B" face in an area that contained a black-gray deposit adjacent to the outside diameter surface. A scanning electron microscope photograph of the same general area is shown in the bottom side of the page. Note the smooth texture of the deposit compared to the rough texture of the fracture. The black-gray deposit is indicated as deposit "9" in table 1.

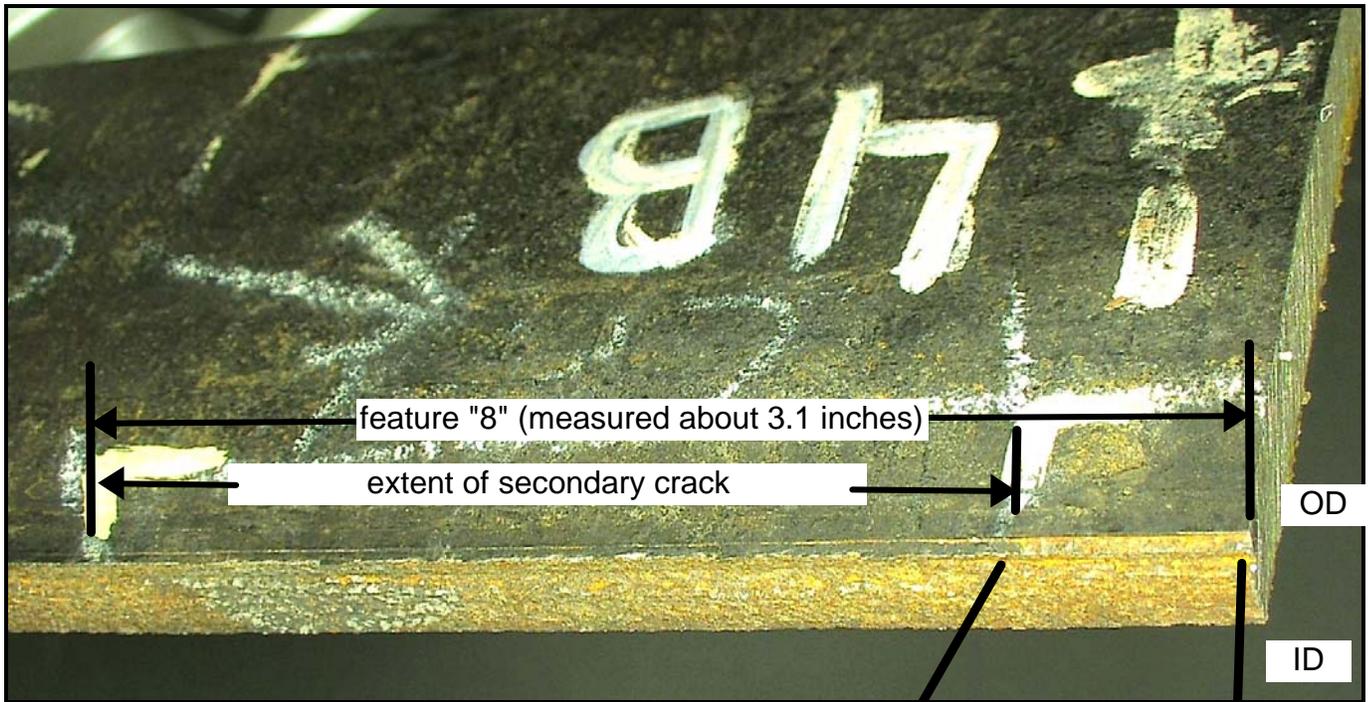
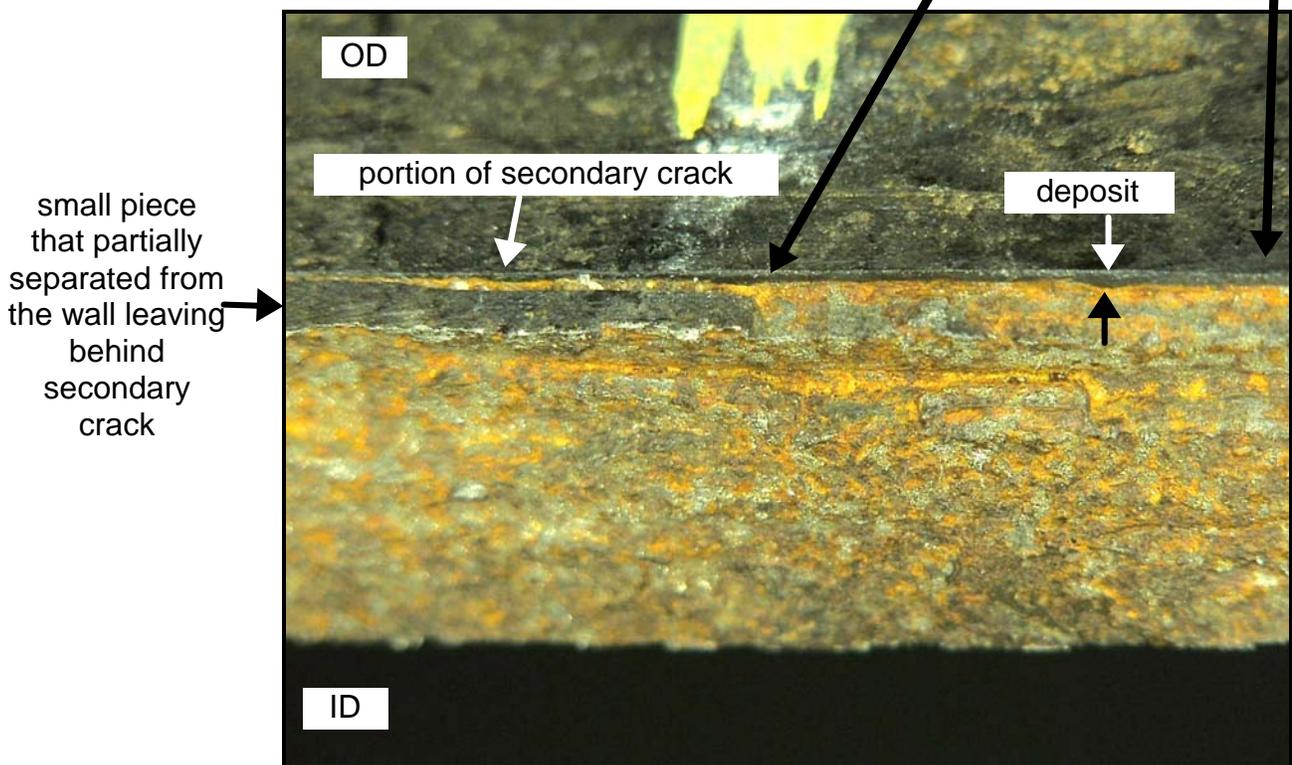
Figure 4 shows photographs of the black-gray deposit "8". The length of deposit "8" measured as long as 3.1 inches, and the depth measured as deep as 0.01 inch. Over most of its length, deposit "8" was found on a secondary crack adjacent to the outside diameter surface. The secondary crack and portion of the deposit that extended into the secondary crack are indicated in figure 4. The deposit was found on at least 90% of the length of the secondary crack.

Figure 4. Photograph of a portion of the fracture from ring piece "4" showing the "B" face in an area that contained a black-gray deposit adjacent to the outside diameter surface. A close-up photograph of the same area where the deposit extended into a crack on the outside surface is shown at the bottom side of the page. The black-gray deposit is indicated as deposit "8" in table 1.

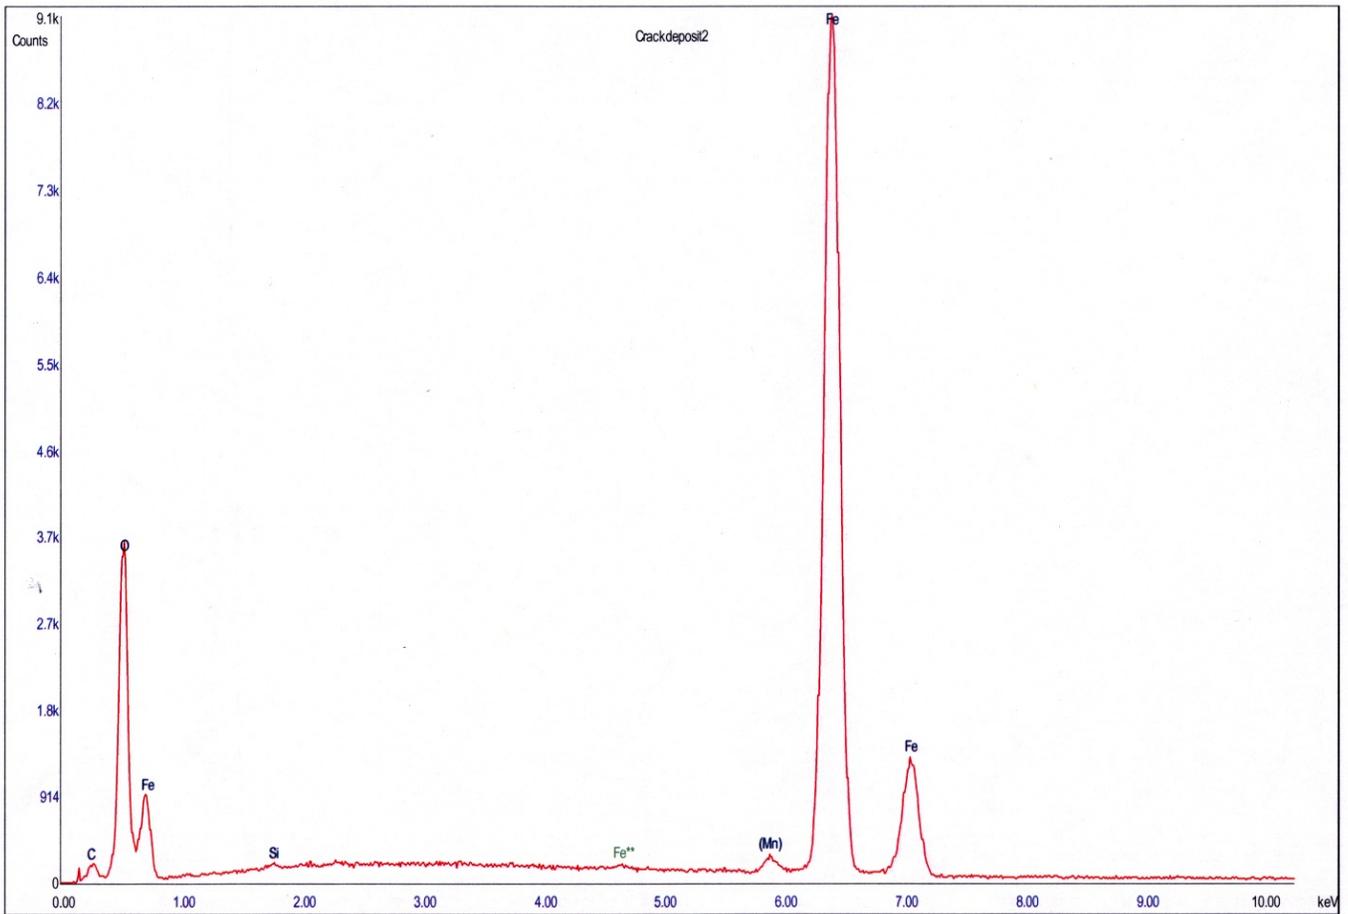
Figure 5. Energy dispersive spectrum of the black-gray deposit shown in figure 3.

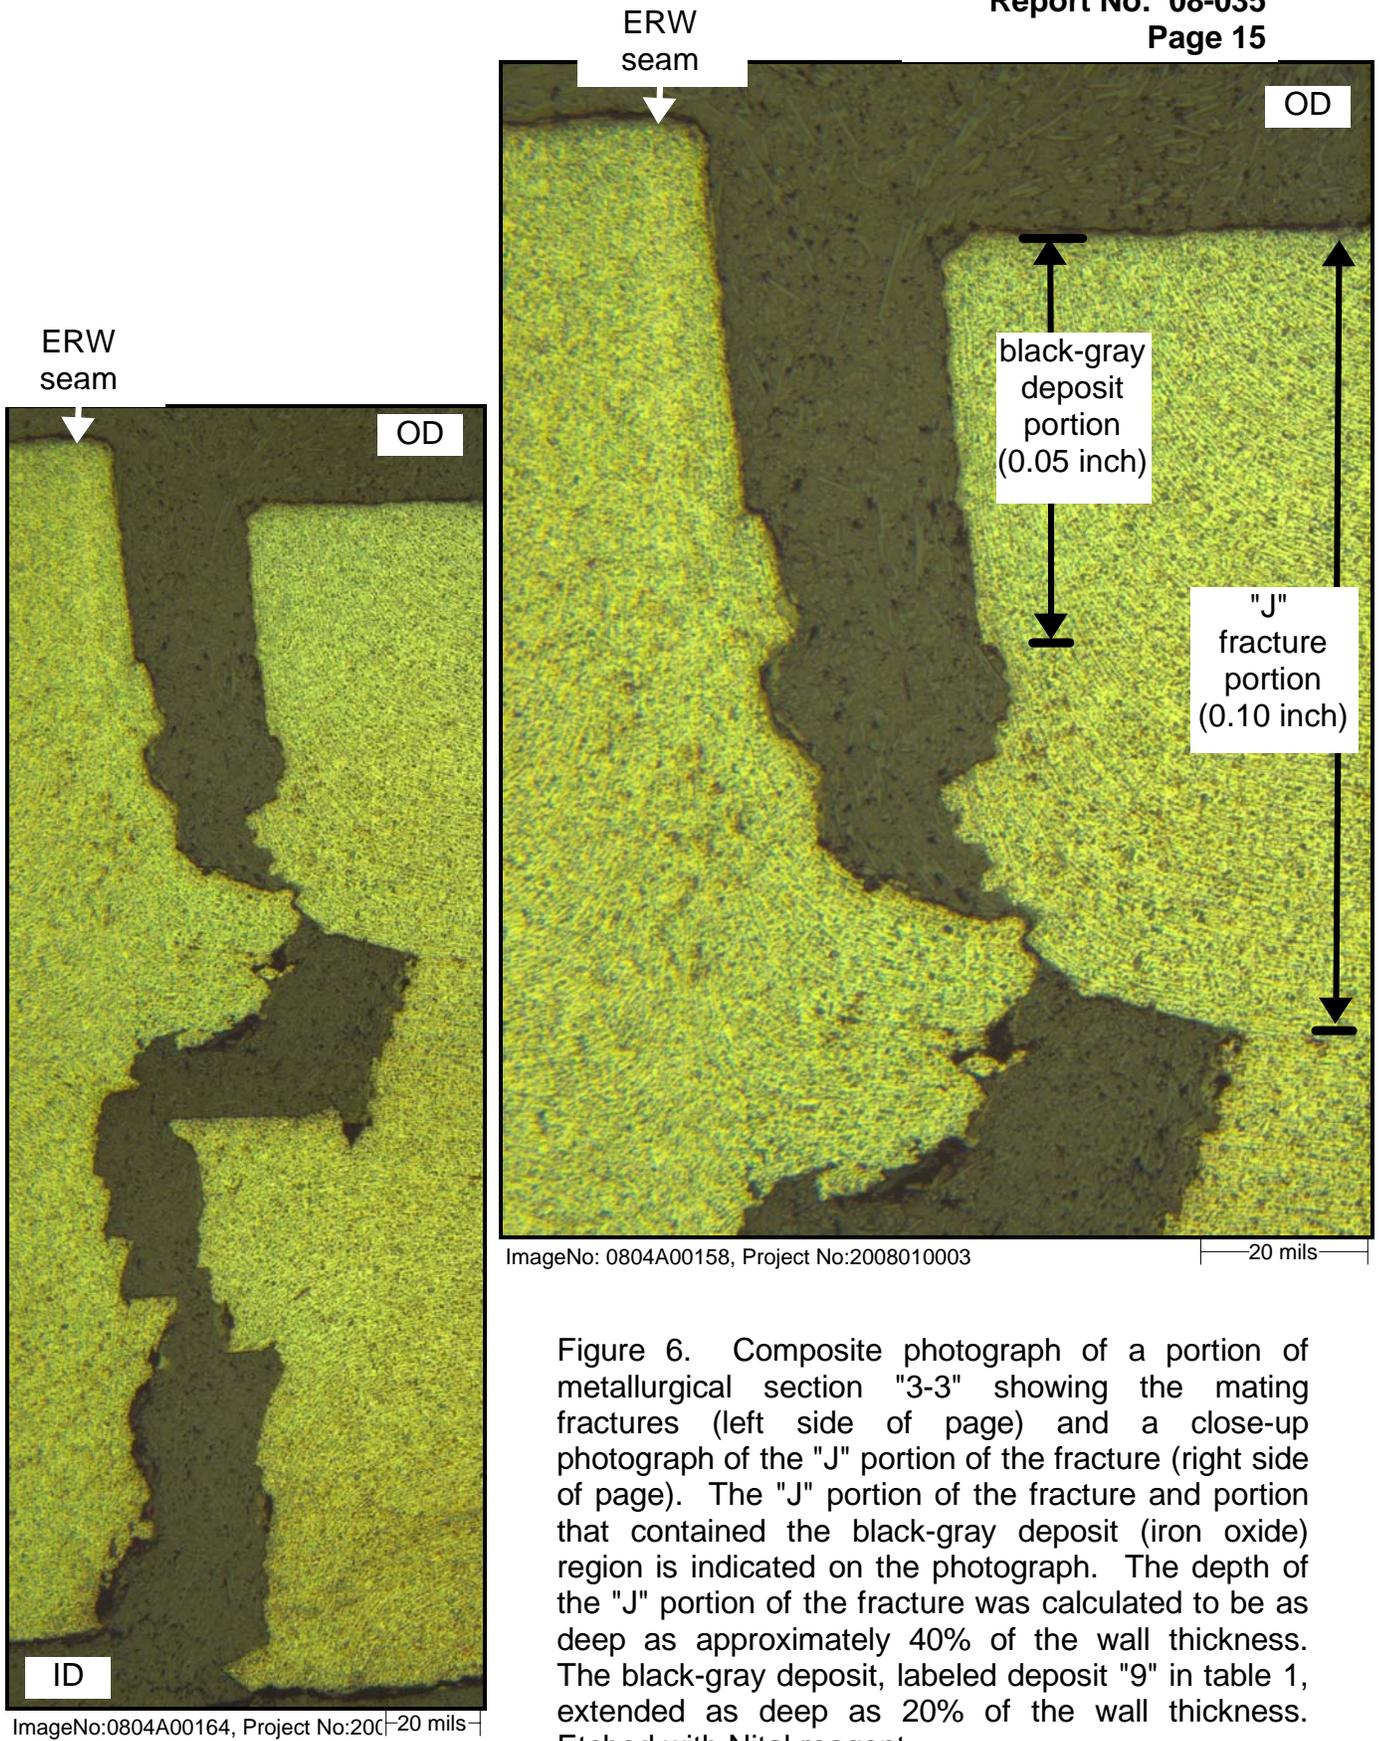
Figure 6. Composite photograph of a portion of metallurgical section "3-3" showing the mating fractures (left side of page) and a close-up photograph of the "J" portion of the fracture (right side of page). The "J" portion of the fracture and portion that contained the black-gray deposit (iron oxide) region is indicated on the photograph. The depth of the "J" portion of the fracture was calculated to be as deep as approximately 40% of the wall thickness. The black-gray deposit, labeled deposit "9" in table 1, extended as deep as 20% of the wall thickness. Etched with Nital reagent.

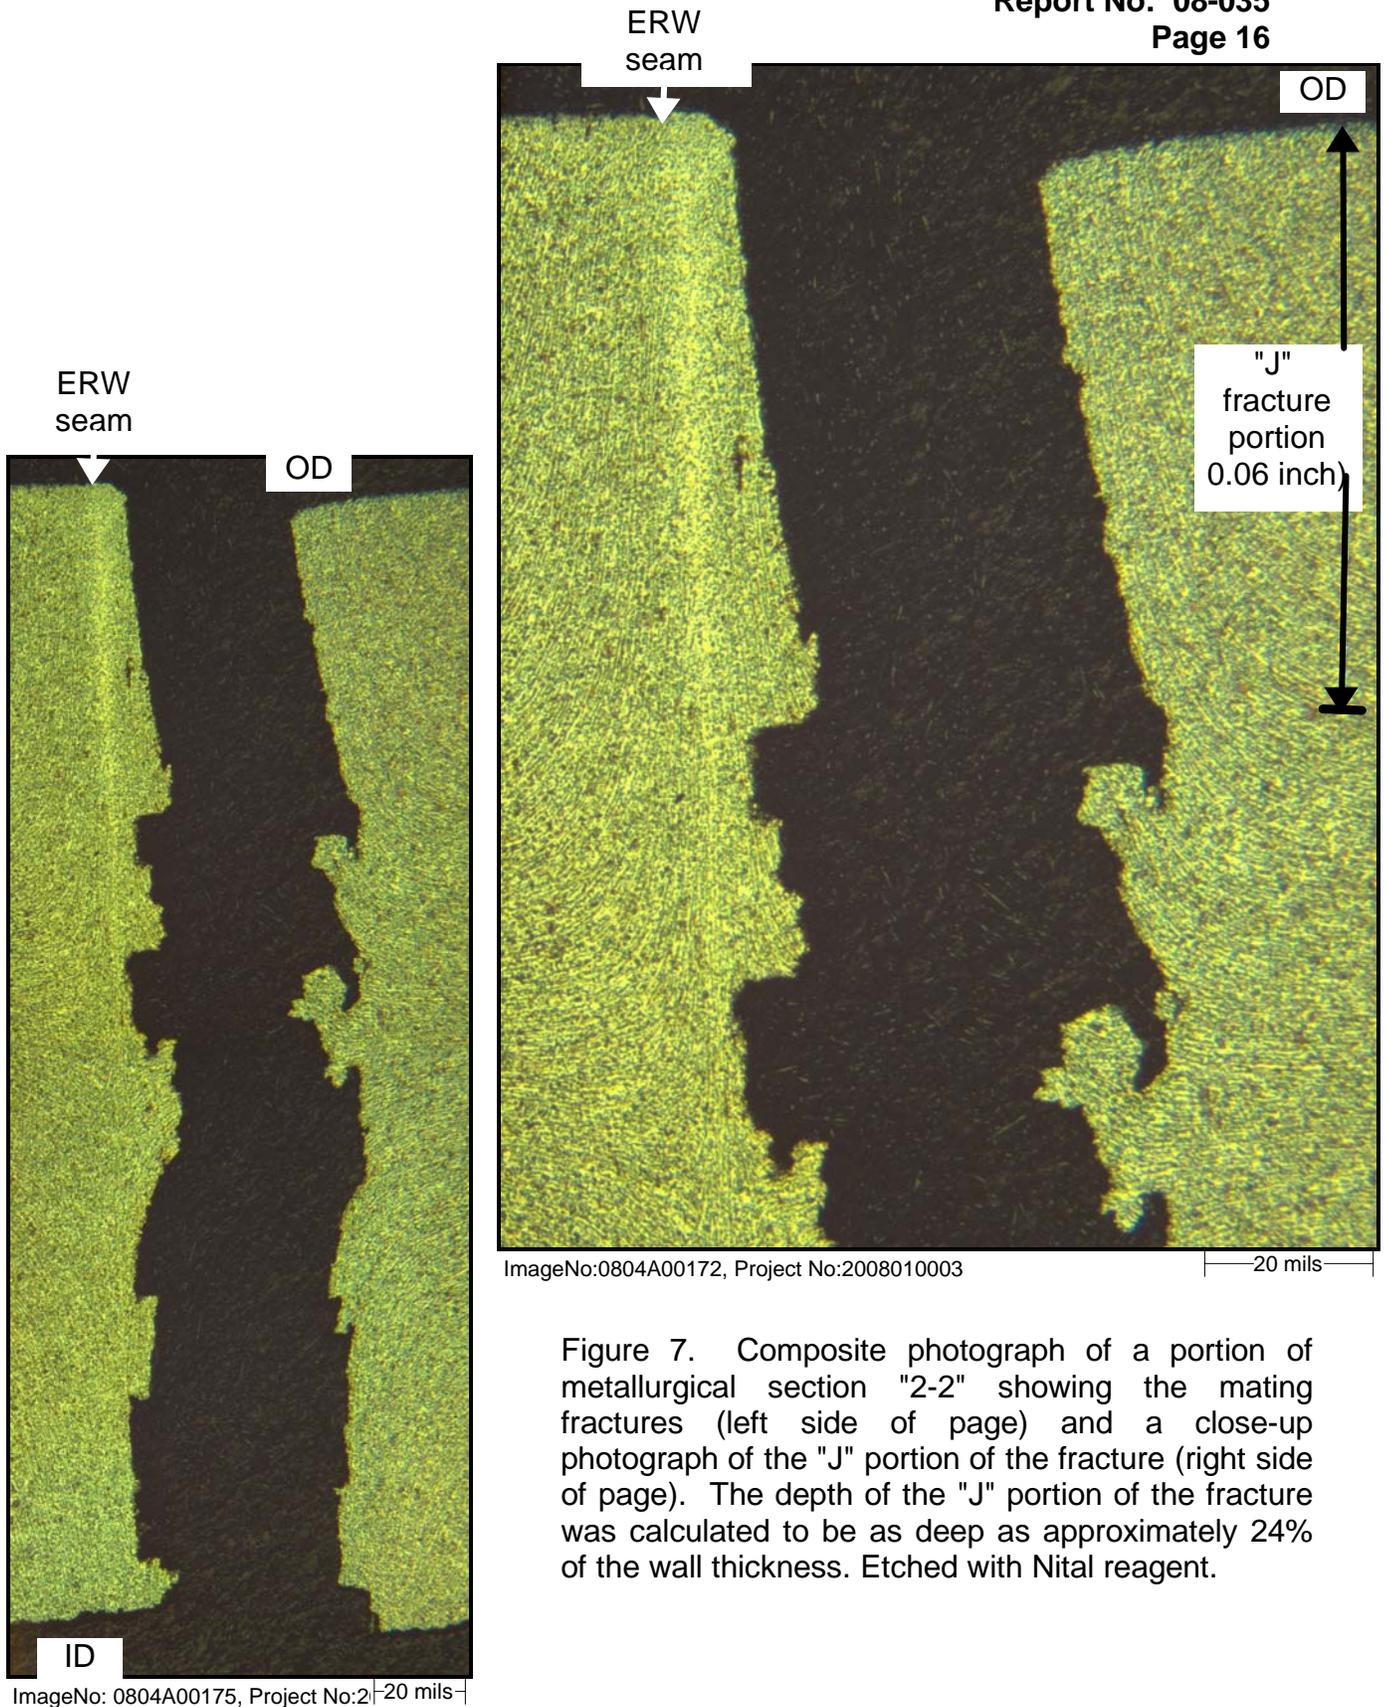
Figure 7. Composite photograph of a portion of metallurgical section "2-2" showing the mating fractures (left side of page) and a close-up photograph of the "J" portion of the fracture (right side of page). The depth of the "J" portion of the fracture was calculated to be as deep as approximately 24% of the wall thickness. Etched with Nital reagent.
